Volvo V40 Front ARB, Poly Bush Replacement

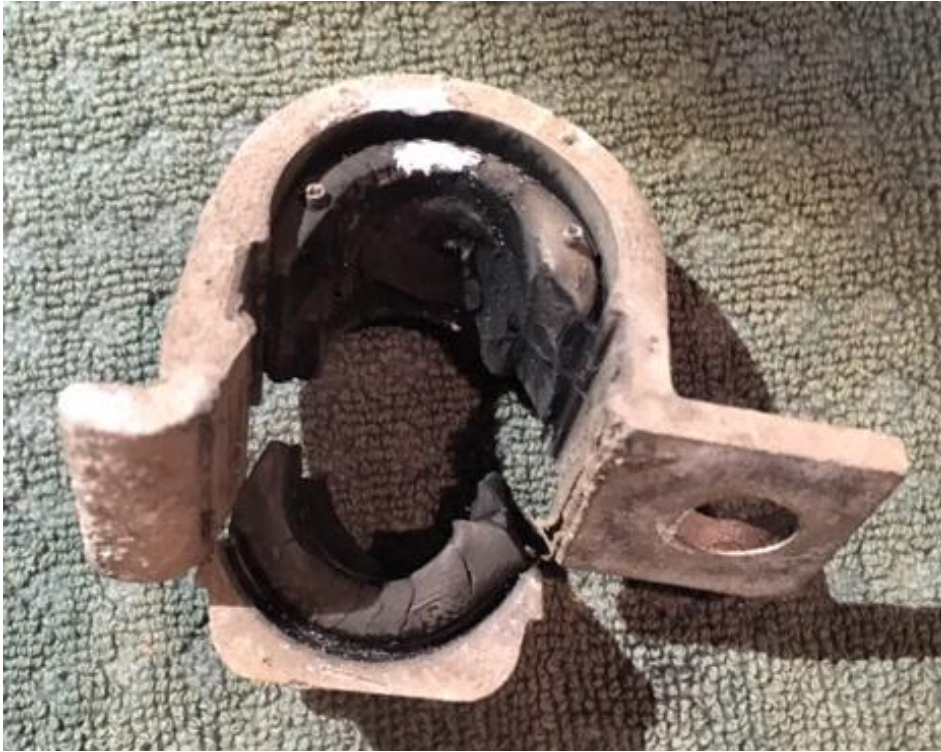
Old (tired) rubber bushes.

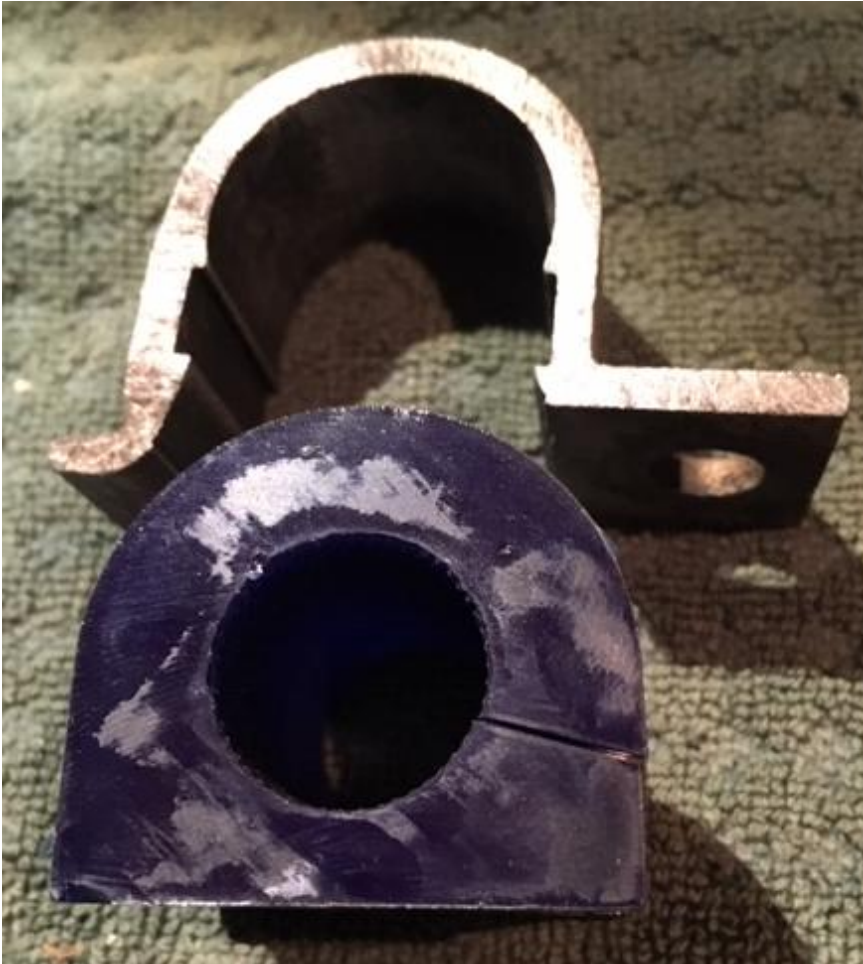
Poly Bush ready for installation, with the split of the bush visible

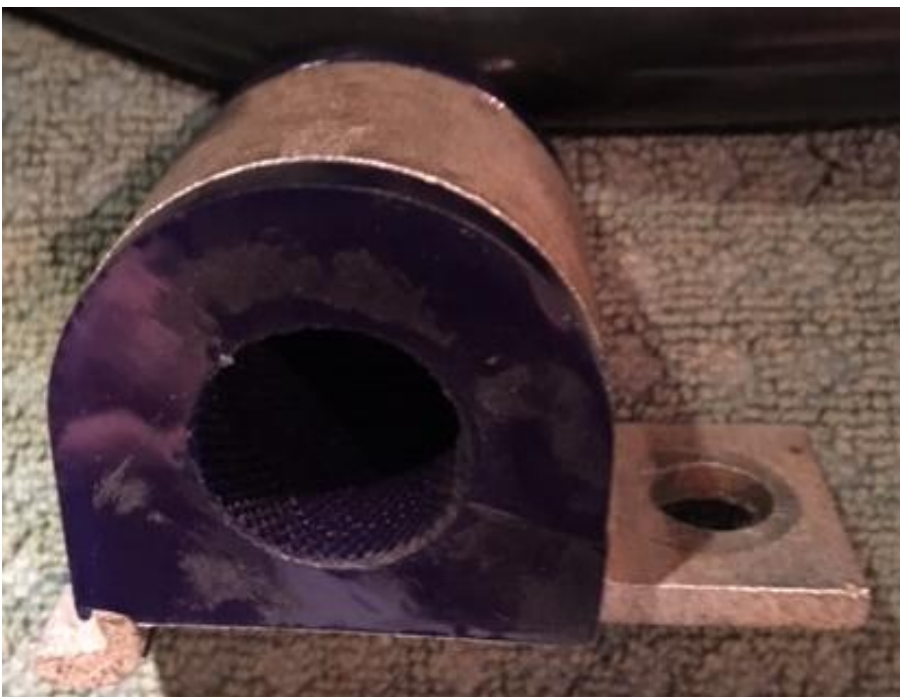
Poly Bush fitted into the bracket to ensure correct size

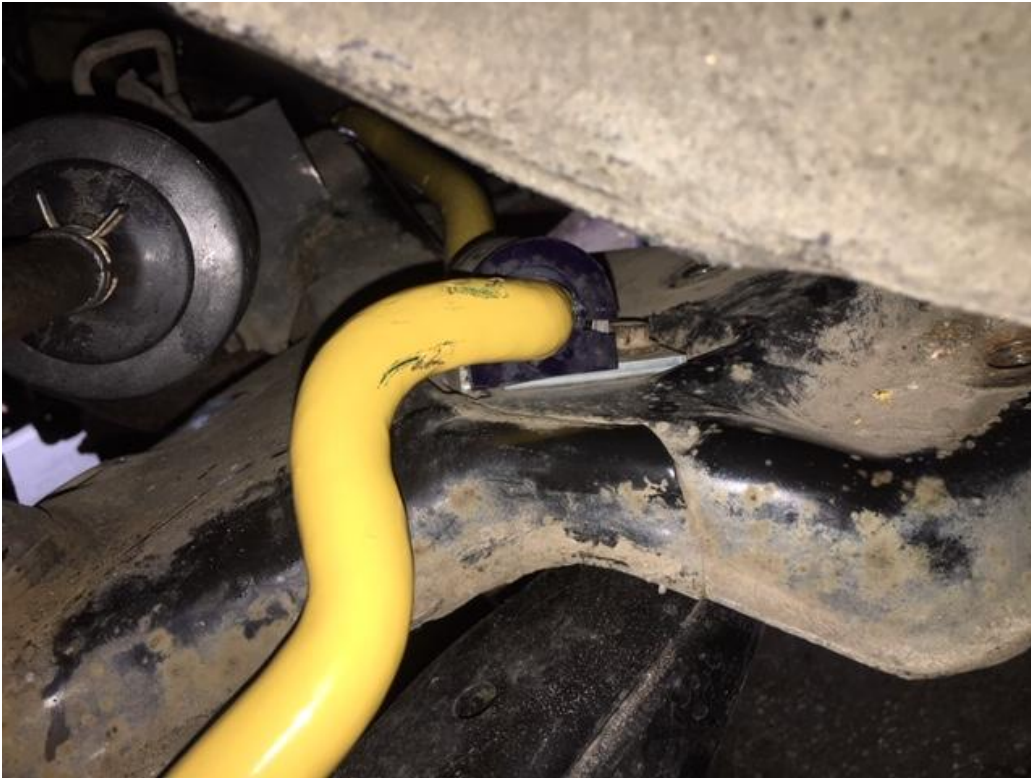
Poly Bush fitted, but even with the extra bottom plate (latest bush design from Volvo), the bush didn't appear to be closed up enough at the rear.
